# GRAĐEVINSKI MATERIJALI I KONSTRUKCIJE

## BUILDING MATERIALS AND STRUCTURES

# A CURRENT PROBLEM FOR STEEL BRIDGES: FATIGUE ASSESSMENT OF SEAMS REPAIR

# ANALIZA OŠTEĆENJA FASADA ZGRADA LAKOG MONTAŽNOG SISTEMA NAKON DUGOGODIŠNJE EKSPLOATACIJE

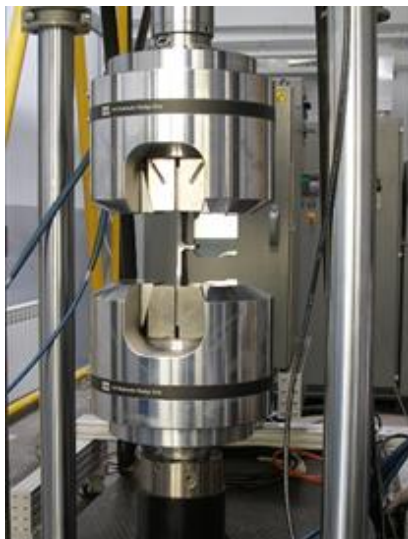
Figure 5. Hydraulic fatigue test machine

The fatigue tests were carried out with frequency of loading 30 Hz using a servo hydraulic fatigue test machine (Figure 5). According to recommendation for fatigue tests the specimens were loaded in five different load levels. To determine a *Wöhler* curve just specimens with the crack at weld toe were taken into consideration. The run-out samples were indicated on diagrams by data points with arrow marks. The fatigue loading was alternating axial tensile with assumption of stress ratio  $R = 0,1$  and fixed slope of *Wöhler* curve  $m = -3$ .

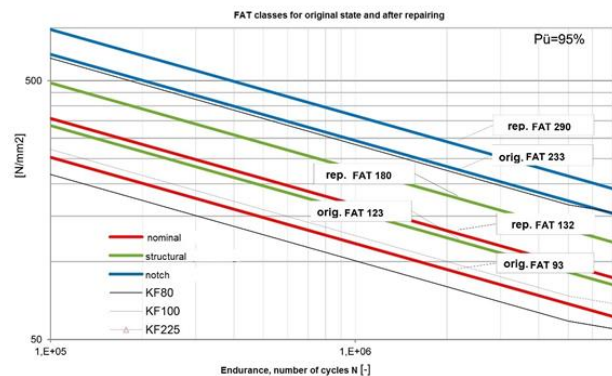
Figure 9. FAT categories of original state and after seams repair

As it was shown in experimental and numerical investigations of steel plates with welded transverse attachment, these repair procedures can lead to considerable improvement of fatigue strength in comparison to original state. In this case, using the post treatment methods with the high frequency hammer is rather no advisable.

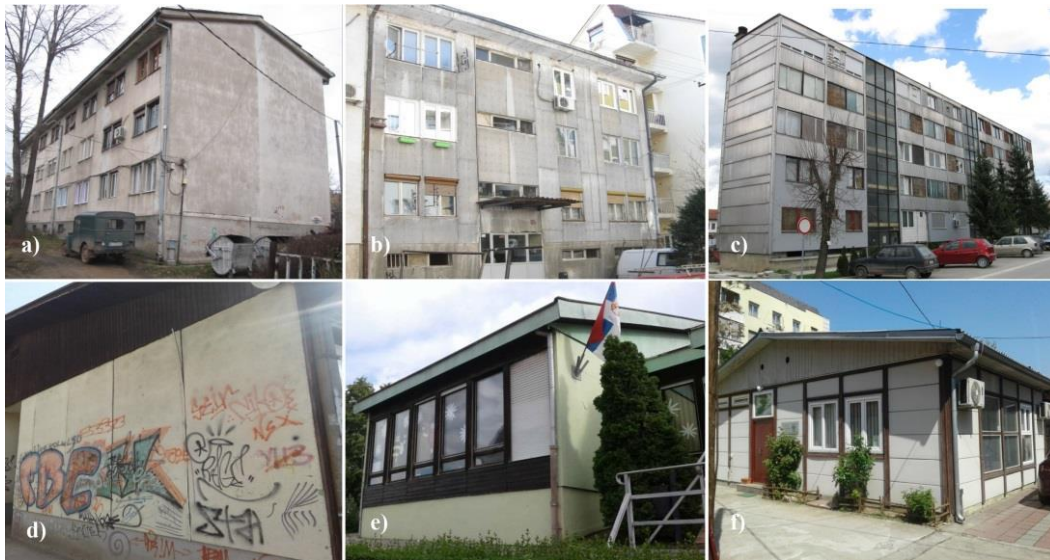
Slika 1. Tipovi fasada lakih montažnih objekata: a) malterisana fasada, b) azbestne ploče, c) limena obloga, d) paneli odIVERICE, e) drvena obloga, f) paneli od lakog betona

This paper analyzes the damage of facades of individual and collective housing buildings in lightweight prefabricated neighborhoods on Apelovac hill and Rasadnik in Nis, built in the early 1960s. In this period, with the rapid industrialization of the city, there was an accelerated construction of entire neighborhoods on the outskirts of the city of Niš. The considered buildings were built in phases in the period from 1958 to 1964 using the system of the Krivaja factory from Zavidovići, Bosnia in Former Yugoslavia. At the time there were no technical norms and standards for construction of buildings of this type, so the data show that the quality of cladding of the buildings constructed in that period fails to meet the present day standards, especially in terms of thermal insulation [25]. A special problem is a sizeable stock of built multi-storey buildings constructed in the second half of the 20<sup>th</sup> century, which is known as a period of intensive housing construction activity. Physical structures built in this period have satisfactory performances in structural sense, but due to the rapid construction process, little attention was paid to creation of building cladding [17]. The standard types of lightweight building facades built in this period were: plastered facades, asbestos panel facades, sheet-metal clad facades, plywood facades, natural timber and light concrete panel facades (Figure 1).

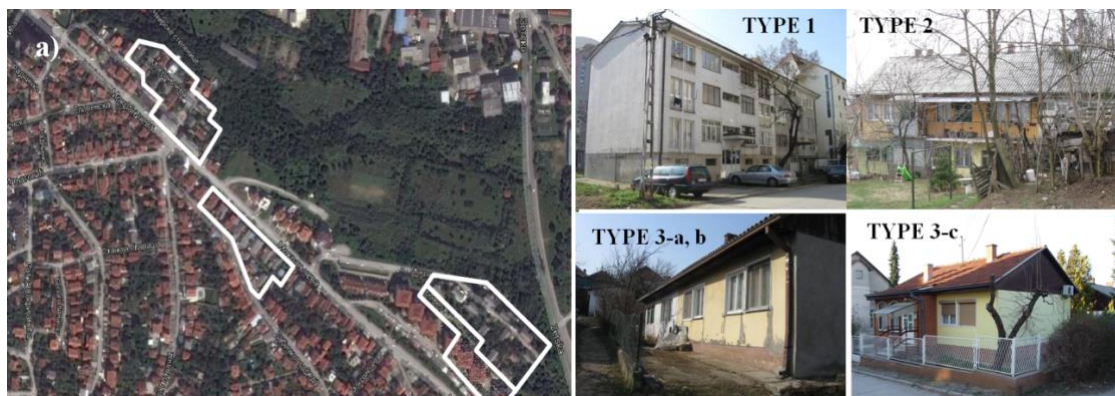
Slika 2. Dispozicijamontažnihnaseljaizgledtipskihobjekata

Figure 2. Disposition of prefabricated neighborhoods and appearance of standardized buildings

The buildings in question are in: Mokranjčeva street, no. 35-37, Mokranjčeva street, access roads II and III and in Rasadnik neighborhood (Figure 2). The subjects of consideration were: six three-storey buildings, two two-storey buildings, seventeen ground level buildings having four apartments, ten buildings with two apartments and five individual houses. Many buildings were extended, which affected the status of facades (in terms of repairs), while many buildings were remediated or fully reconstructed using contact facades.

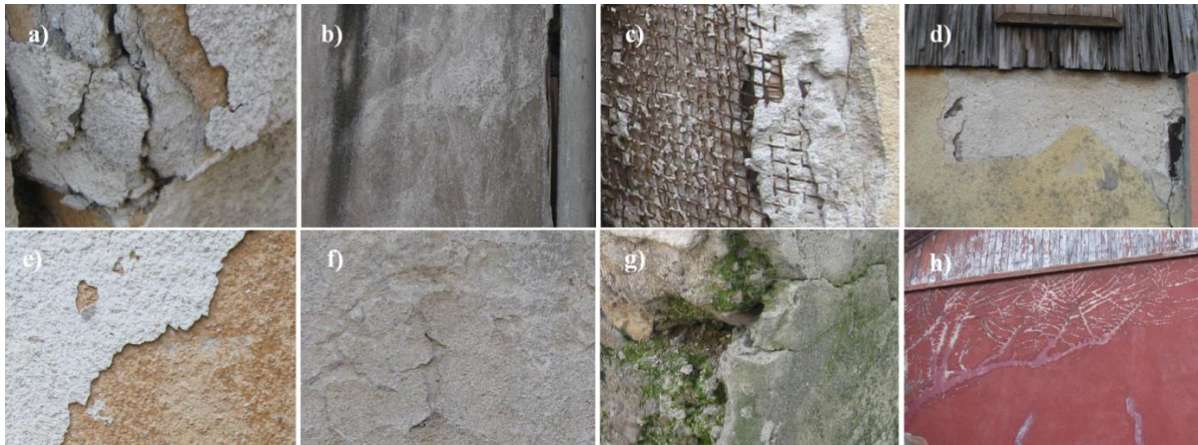
Slika 4. Karakteristična oštećenja malterisanih fasada (slika: P. Petronijević)  
 Figure 4. Characteristic damage of plastered facades (photo: P. Petronijević)

Defects of the plastered facades [16] in this research were classified as: disintegration of the mortar layer, total separation of the façade from substructure, falling off of the mortar and corrosion of the wire mesh, falling off of the finish mortar layer, flaking of the façade finish layer, network of cracks from shrinkage, occurrence of moss and lichen, flora development, cracks and crevices resulting from the geometry of substructure, falling off of façade parts (Figure 4).

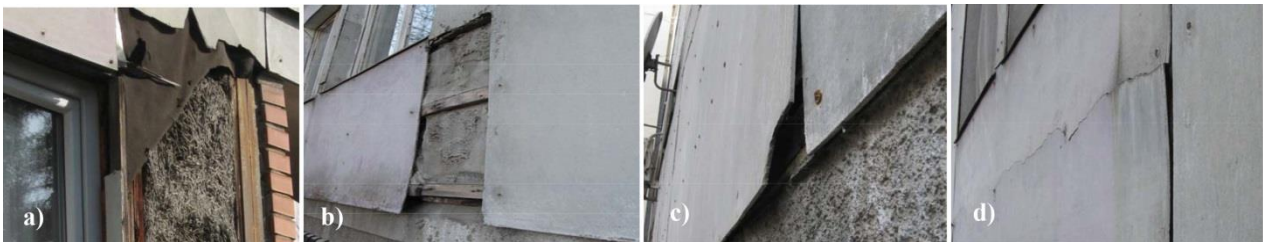
Slika 5. Karakteristična oštećenja fasadnih panela od azbesta (slika: P. Petronijević)  
 Figure 5. Characteristic damage to the asbestos panels (photo: P. Petronijević)

Characteristic damage of asbestos panel façade are classified as : complete disintegration of the wall, falling off of panels, panel edge breaking, warping of panels, cracks and crevices of panels, separation of panels from the substructure, roofing paper damage (Figure 5).

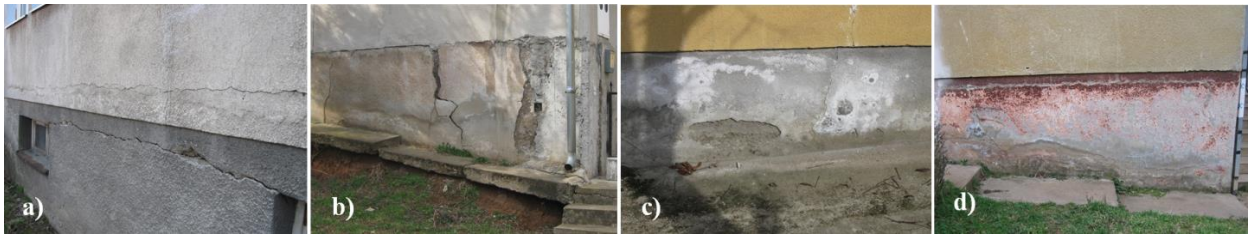
Slika 6. Oštećenja temeljnog zida: a) strukturalne pukotine, b) otpadanje obloge, c) iscvetavanje, d) karbonatizacija  
 Figure 6. Plinth wall damages: a) structural cracks, b) wall cover falling off, c) salt crystallization, d) carbonation

Structural cracks in the foundation walls were recorded in a number of samples. Longitudinal cracks at the level of the basement ceiling and vertical cracks of the corners of the buildings are the result of the inadequate reinforcing of basement walls (Figure 6-1). Diagonal cracks are identified in the structures founded on an inclined ground as the consequence of irregular settling. Regarding small mass of this type of buildings, irregular settling was caused by the different ground compaction degree at various depths of founding. The durability of the finish layer of the plinth was affected by the frost and damp due to dilapidation of vertical waterproofing in the foundation walls. Most often recorded damage was: falling off of the plinth, salt crystallization, carbonation, biodegradation, damage of the finish decorative coating.

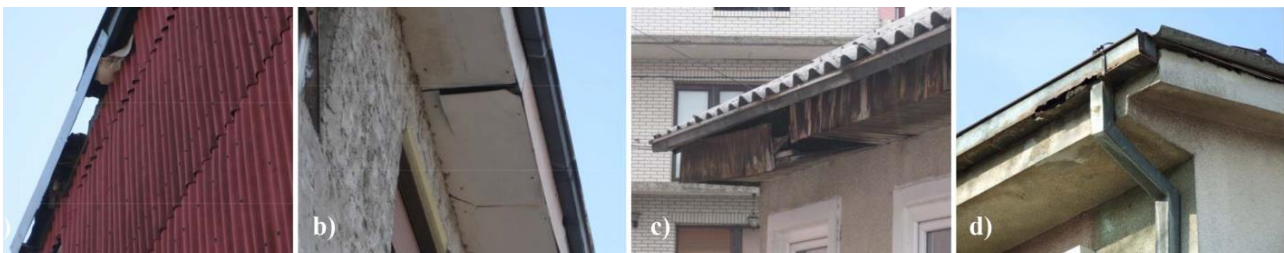
Slika 7. Oštećenja strehe (slika: P. Petronijević)  
 Figure 7. Damage to the eaves (photo: P. Petronijević)

Damage to gable walls, chimneys, ventilation ducts, eaves, downpipes give evidence of the total neglect of the buildings by their owners. On all the buildings, except Type 3-c there are original elements after 60 years. The roof flashing damage was recorded, irrespective of the used type of material (Figure 7-b,c). Many buildings lack: parts of gable walls, sheet-metal flashing of the roof, parts of gutters, roofing panels etc.

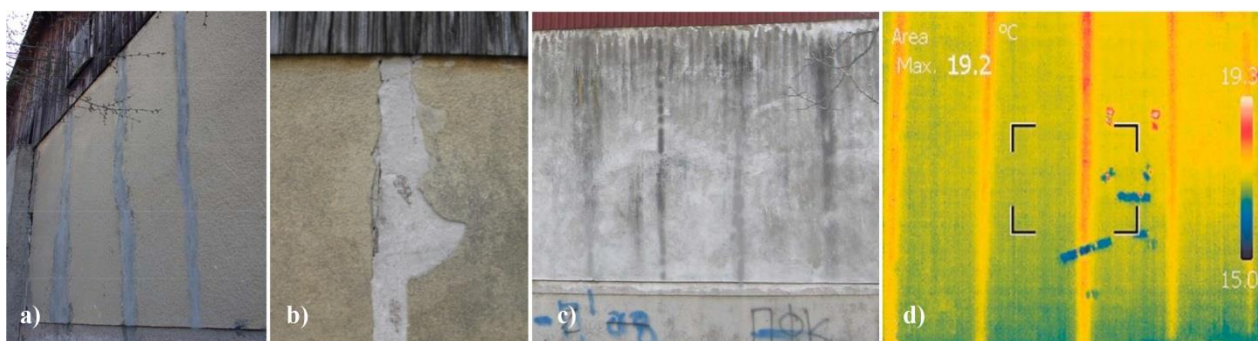
Partially improved cross section of the external wall with additional insulation of 5 cm was still bad because of poor sealing. Heat passage coefficients, temperature retardation and temperature damping factor are many times below the values required nowadays. Subjective feel of living in such apartments is very low because of poor insulation, short phase shift and absence of any considerable temperature damping factor [29]. Heat passage coefficient is reduced by the increase of thermal insulation layer thickness. Whereas, the temperature retardation coefficient and temperature damping factor are hard to achieve even in the contemporary prefabricated construction. A higher temperature retardation can be achieved with additional mass of material and arrangement of layers (Figure 8-c). In case of prefabricated construction this considerably increases the cost of façade panels [22,23]. The external air temperature of the external wall surface oscillates during daytime. The amplitude of the temperature wave penetrates through the wall layers and gets decreased – damped. Temperature damping is a characteristic parameter used to describe heat stability of the structure. Damping factor is the ratio of amplitude of temperature oscillation of outside air and amplitude of interior wall surface [8].

Slika 9. Oštećenja fasadnog maltera usled bubrenja drvene građe, mrlje na mestima termičkih mostova (slika: P. Petronijević), Efeka termičkog mosta na mestima čeličnih profila kod zidova lakih montažnih konstrukcija [24]

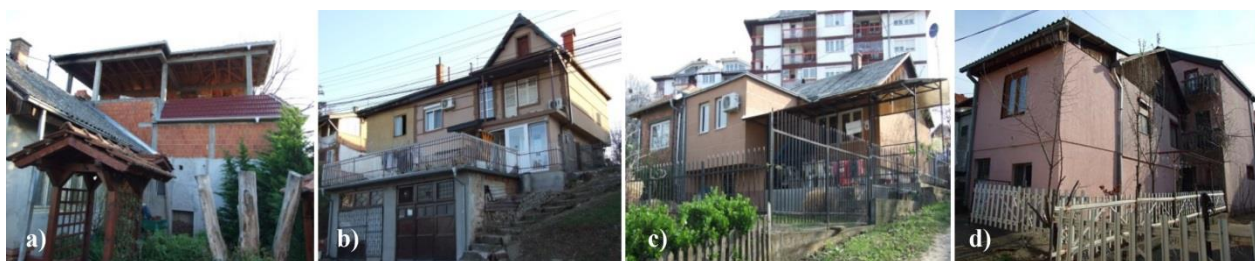
Slika 14. Dogradnja objekata Tip 3-b (Apelovac, 2019)  
Figure 14. Upgrades of buildings Type 3-b (Apelovac, 2019)

S obzirom na to što se analizirana naselja nalaze na rubnim delovima grada, poslednjih dvadeset godina su izložena intenzivnoj nelegalnoj gradnji. Dogradnje su izgrađene u potpunom neskladu s postojećim objektima, bez ikakve međusobne usaglašenosti i tipizacije. Novoizgrađeni delovi po gabaritima prevazilaze i nekoliko puta postojeće objekte (Slika 14). Bespravnim nadziđivanjem i doziđivanjem preko postojećih gabarita objekta u potpunosti je naružen izgled i vizuelni identitet naselja.

Regarding that the analyzed districts are on the periphery of the city, they have been exposed to intensive illicit building in the last 20 years. Upgrades were constructed in a total disharmony with the existing buildings, without any mutual coordination and typifying. Newly constructed sections exceed the existing buildings for several times, in terms of their size (Figure 14). Illicit extensions and additions of floors over the existing building dimensions entirely marred the visual identity of the district.

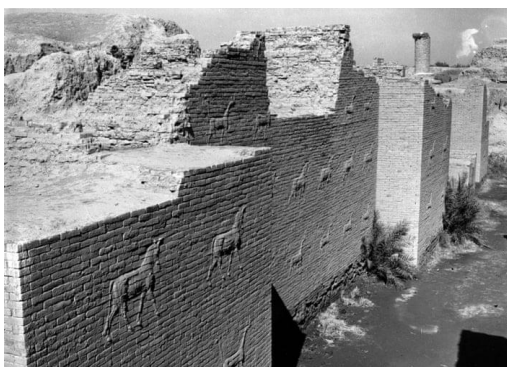
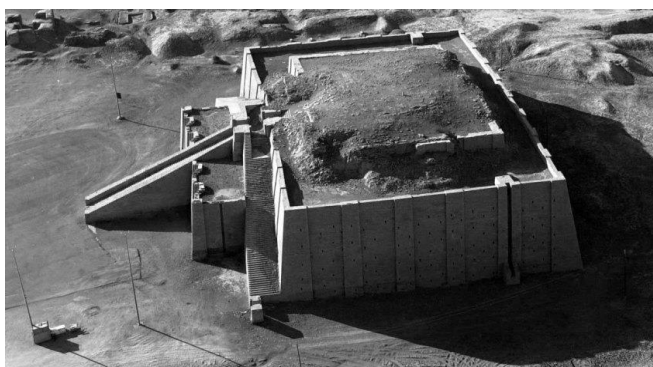
*Slika 3. Poprečni presek kroz zid Kapije boginje Ištar, Vavilon; Novosumerski zigurat u Uru, prema [126]  
Figure 3. Cross section of the Ishtar Gate of Babylon; New-Sumerian ziggurat of Ur, after [126]*

Iznuđene kao odbrana od velikih poplava bujičnih reka, osmišljene su visoke platforme na kojima su bile izgrađene palate i hramovi. Bile su izvedene od jednoobrazne i simetrično postavljene mase, a time su i značajno spuštale težište cele strukture i tako istovremeno predstavljale odbrambeni sistem od zemljotresa. Dimenzije površinskog zemljotresnog talasa bile su srazmerne dimenzijama platforme, tako da je zadatak velike, krute platforme bio da ublaži taj talas. Građevina na platformi bila je podvrgnuta samo prosečnom pomeranju tla usled zemljotresa, bez nepredvidljivih pikova (slika 4).

High platforms on which palaces and temples were built were a forced solution as a defence against large floods of torrential rivers. They were made of a uniform and symmetrically placed mass, and thus at the same time significantly lowered the centre of gravity of the entire structure and simultaneously represented the earthquake resistant system. The dimensions of the surface earthquake wave were proportional to the dimensions of the platform, so the task of the large, rigid platform was to mitigate that wave. The building on the platform was subjected to only average ground movement due to the earthquake, without unpredictable peaks (Figure 4).

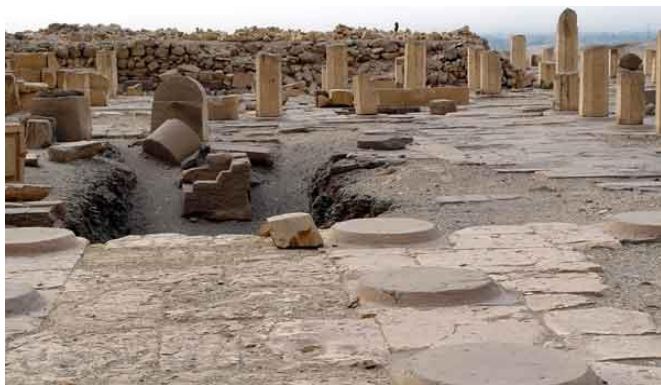
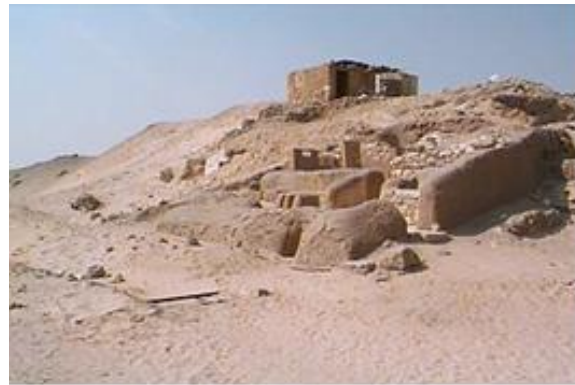
*Slika 5. Platforma grobnog hrama u Deir-el-Bahariju; Kompleks grobnica graditelja piramida kod Gize, prema [101] i [129]*

*Figure 5. Platform of the sepulchral temple in Deir-el-Bahari (a); The complex of tombs of the Giza pyramid builders (b), after [101] and [129]*

Građevine postavljene na čvrstoj steni često nisu imale duboke temelje. U ranoj Dvanaestoj dinastiji (1991–1802. p. n. e.) prvi put se potvrđuje metoda izravnavanja tla. Mekana zemljišta su uklanjana i zamenjivana novim, peskovitim materijalom, što je i danas jedna od široko primenjivanih metoda. Jedan način bio je postavljanje velikog broja manjih blokova (koji se ponekad uzimaju iz starijih objekata) koji stvaraju neku vrstu podzemne platforme na kojoj je podignuta građevina. Drugi način je bio da se u pripremljene temeljne jame ili trake nasipa suvi pesak, koji je zbog svoje kompaktnosti izvanredno podnosio pritisak. Slično su Egipćani postupali i sa stenovitim podlogama, koje su nivelisali do horizontalnog položaja, a preko tako zaravnjene podloge nasipali su, takođe, sloj peska. Uloga pešćanog sloja bila je dvojaka. S jedne strane, opterećenje građevine ravnomerno se prenosilo na tlo, pa otuda nema koncentracije napona u temeljima. S druge strane, sloj peska je imao funkciju izolacionog sistema koji je upijao seizmičke talase i omogućavao građevini da klizi preko njega tokom pokreta tla (slika 5a i slika 5b).

Buildings built on solid rock often were without deep foundations. In the early Twelfth Dynasty (1991-1802 BC), the method of levelling the ground was confirmed for the first time. Soft soils were removed and replaced with new, sandy material, which is still one of the widely used methods. One way was to set up a large number of smaller blocks (sometimes taken from older buildings) that created a kind of underground platform on which the building was erected. Another way was to pour dry sand into the prepared foundation pits or strips, which, due to its compactness, withstood the pressure extraordinarily well. The Egyptians acted similarly in the case of rock beds, which were levelled to a horizontal position, and also a layer of sand was poured over such a flat surface. The role of the sand layer was twofold. On one hand, the load of the building was evenly transferred to the ground, so there is no concentration of stress in the foundations. On the other hand, the sand layer had the function of an insulating system that absorbed seismic waves and allowed the building to slide over it during ground movement (Figure 5a and Figure 5b).

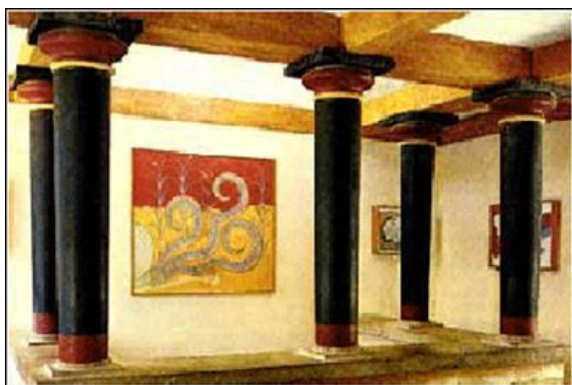
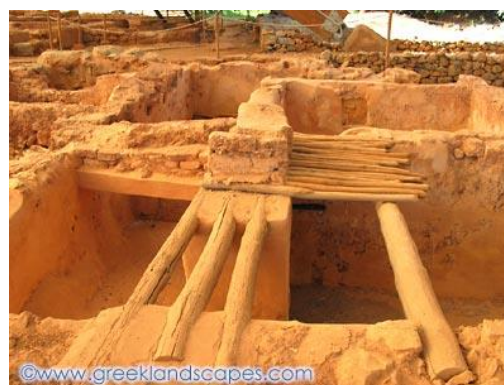
Slika 6. Deo palate sa stubovima u Knososu na Kritu; Ostaci palate u Malji na Kritu, prema [113 i [130]  
Figure 6. Part of the palace with columns in Knossos on Crete (a); remains of the palace in Malia on Crete (b) after [113] and [130]

ovakav oblik stuba proistekao iz potrebe seizmičke otpornosti. Oblik kapitela stuba je pogodan da prihvati jedan deo gredne konstrukcije, dok je u bazi, sužavanjem stuba u odnosu na vrat, formiran zglob. Na taj način, stub može biti samo pritisnut, ali ne i izvijen. Pored ove osobenosti u oblikovanju stubova, osiguranje velikih trospratnih, pa i višespratnih zgrada bilo je izvedeno veoma dubokim fundiranjem velikog broja podužnih i poprečnih zidova, koji su međusobno bili povezani. Broj temeljnih zidova bio je znatno veći od broja zidova na spratovima zgrada (slika 6 a i b).

proposed theory is that this shape of the pillars originated from the need for seismic resistance. The shape of the capital of the pillar is suitable to support one part of the beam structure, while at the base, by narrowing the pillar in relation to the neck, a joint is formed. In this way the pillar can only be pressed, but not bent. In addition to this feature in the design of pillars, the securing of large three-storey and even multi-storey buildings was carried out by very deep foundations of a large number of longitudinal and transverse walls, which were interconnected. The number of foundation walls was significantly higher than the number of walls on the floors of buildings (Figure 6 a and b).

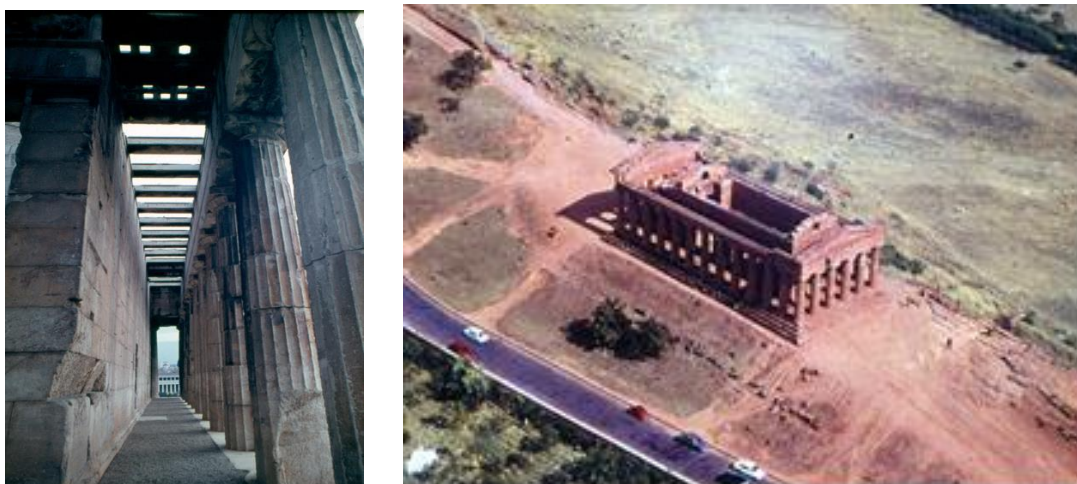
*Slika 9. Ostaci krovne konstrukcije hrama Tezeon (Hefestion) u Atini i urušena krovna konstrukcija hrama u Segesti, prema [prvi autor 62]*

*Figure 9. Remains of the roof structure of the temple of Theseus (Hephaestion) in Athens (a) and the collapsed roof structure of the temple in Segesta (b), after [authors] and [62]*

Današnje stanje grčkih hramova najbolje svedoči o navedenim nedostacima, pošto nijedan primer nije sačuvan u celosti, već im nedostaje upravo deo nadstavlja, koji je bio najteži i koji se urušavao pri svakom zemljotresu. Najbolje sačuvanom grčkom hramu, Tezeonu (Hefestionu) na atinskoj agori, takođe nedostaje i krov, iako je veliki broj tavanjača ostao sačuvan (slika 9).

The present day condition of Greek temples is the best evidence of the mentioned shortcomings, because no structures have been preserved in their entirety, but they are missing exactly the part of the superstructure, which was the heaviest and which collapsed during every earthquake. The best-preserved Greek temple, Theseus (Hephaestion) on the Athenian Agora, also lacks a roof, although a large number of roof beams have been preserved (Figure 9a) and (Figure 9b).

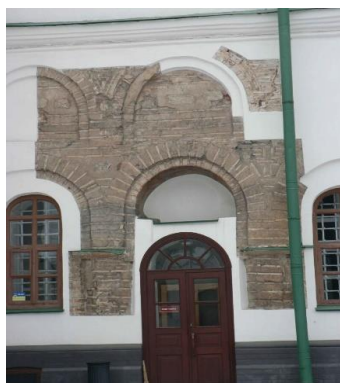
Slika 12. Prezentacija tehnike građenja i rekonstrukcija prvobitnog oblika Crkve Svete Sofije u Kijevu, prema [133]  
 Figure 12. Presentation of construction techniques and reconstruction of the original shape of the Church of St. Sophia in Kiev, after [133]

The churches of Kievan Rus', developed under the considerable influence of the Byzantine experience, primarily the cathedral church of St. Sophia in Kiev, were built using the technique of so-called "hidden" or indented rows of bricks, which are covered with mortar on the outside, which appear as joints of the same thickness as the rows of bricks. The properties of bricks and lime mortar with ceramic additive (mechanical strength, mineralogical, chemical and micro structural analyzes) were examined and they showed great similarity with the early Byzantine buildings of Constantinople, confirming the properties of seismically resistant construction techniques and materials that are properties of continuous stress and expansion (Figure 12).

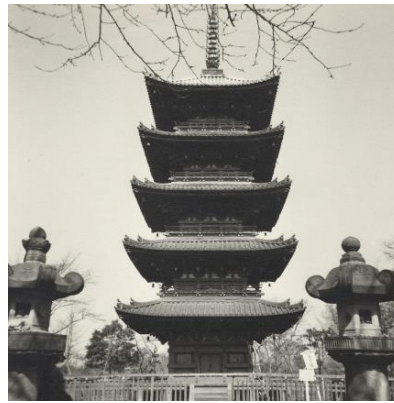
Slika 17. Shema višespratne pagode i Velika pagoda u Nari, prema [62]  
Figure 17. Diagram of the multi-storey pagoda and the Great pagoda in Nara, after [62]

In Japan, an area of exceptional seismic activity throughout history, ancient builders improved the construction of multi-storey timber temples, pagodas, which initially poorly withstood earthquakes and collapsed. In order to prevent the transfer of vibrations from the earthquake, a column was inserted into the vertical axis of the building, placed in a cylindrical socket, which introduced pressure and increased the resistance to bending of the cantilever structure. When the pagoda vibrated due to the earthquake, part of the vibration energy was converted into oscillations of the column, which dissipated energy by hitting the socket sides (Figure 17). In contemporary conditions, the same result is achieved with the equipment that automatically responds to seismic actions, which is the subject of structures management.

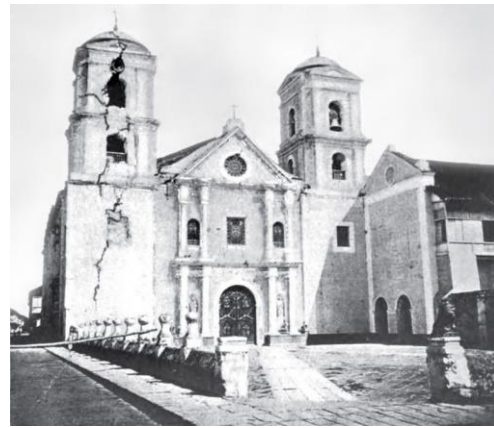
Slika 18. Tipična kolonijalna Crkva u J. Americi (a), Crkva Svetog Avgustina u Manili nakon zemljotresa 1880. godine, prema [92] i [62]

Figure 18. Typical western façade of Spanish colonial churches (a): Church of St. Augustine in Manila after the earthquake of 1880 (b), after [92] and [62]

In the Philippines, the Augustinian monastic order built several churches in the 1790-1800 period in a distinct "earthquake baroque" architecture. These churches were stocky and not too tall, and followed the style adopted in the seismic zones of Mexico and South America (Figure 18a). A new "mestizo" architecture was created and it is most often translated as "earthquake baroque". When the earthquakes of 1863 and 1880 again devastated Manila, almost all the buildings collapsed, except, again, the church of St. Augustine (Fig. 18b).
